ComFlor Case Study

ComFlor 80: Northern Busway

ComFlor helps Northern Busway safely cross State Highway 1

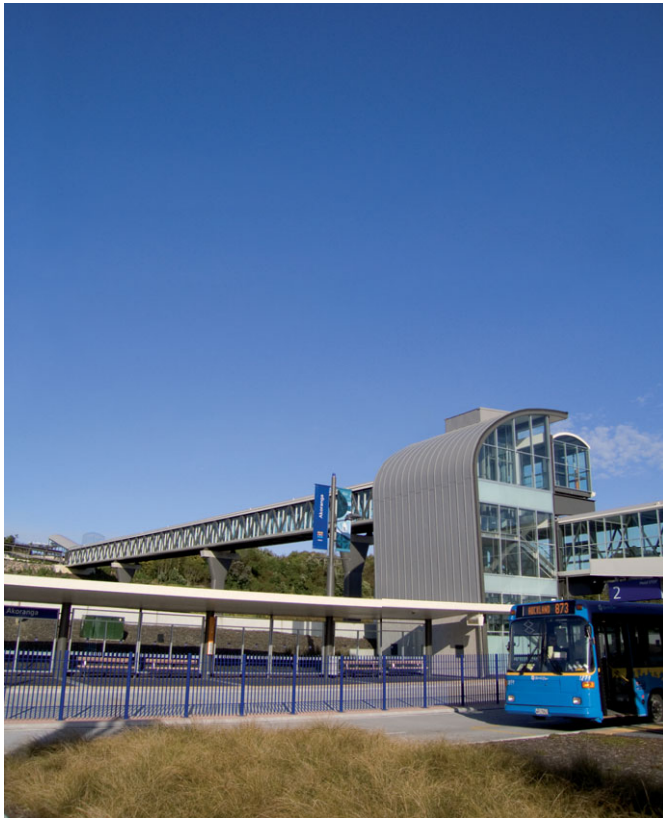
ComFlor used in the Akoranga footbridge on the Northern Busway.

The flooring system was changed from Hollowcore to Comflor 80 steel decking, manufactured by Corus New Zealand Ltd. Comflor 80 was chosen because it would enable the bridge spans to be lifted into place at a reduced weight, and the concrete topping could be poured after erection." (Source: SCNZ Magazine)

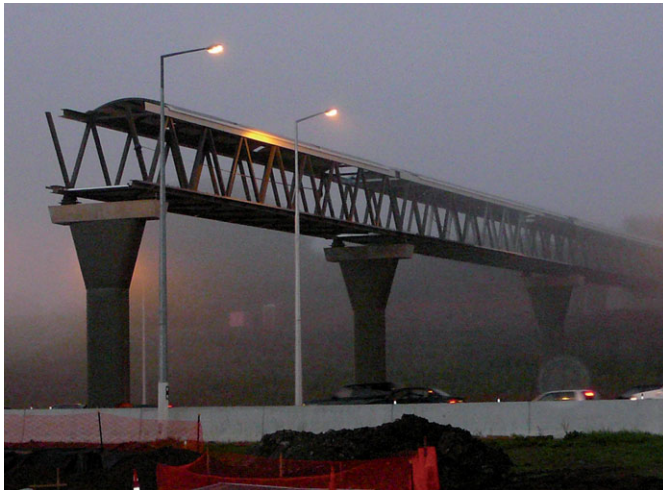
The spans were trucked to the site ready for erection. Working at night to minimise traffic disruption, NZ Strong Construction Ltd and Auckland Steel completed the erection in three lifts. State Highway 1, one of the busiest in the country, was closed in both directions from 10.00pm to 4.00am on two nights and in one direction on a third night.

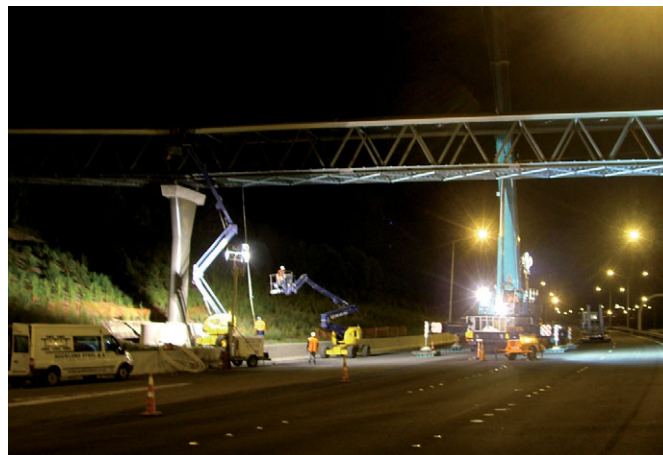
This much was straightforward, but the erection methodology for the glass-walled closed footbridge required some input from the main contractor, NZ Strong. The company’s in-house engineers, in close consultation with Occupational Safety & Health (OSH) at the Department of Labour, designed a fully enclosed trolley platform that could roll out across the spans. This allowed work to continue while the motorway was in use (see photograph bottom right).

The trolley or gantry had an 11m long working platform and was constructed on wheels that sat within the external gutter of the bridge. It was equipped with two manual turfers with which it was pulled in stages along the 120m length of the footbridge. NZ Strong chose to operate it manually because of the risk that a power failure would pose. Supervisor Megan Roberts: “After some careful programming, we worked out that the trolley needed to make only two runs across the bridge spans and back. The staged installation
